**Flood Control Project Maintenance
Levee Inspections**
LMA District Cover Sheet
Spring 2020 Levee Inspection Results

Lower San Joaquin Levee District

Spring 2020 Levee Inspection Results

Waterway			Bank	Unit Miles
Unit No. 01 San Joaquin River			Right	22.52
	Spring (March - May)	Summer (June - August)	(September - November) Fall	Winter (December - February)
Unit Maintenance Rating (Fall Only)				
Date of Inspection	4/21/2020 - 4/21/2020			
DWR Inspector	Corey Fujitani			
Accompanied By

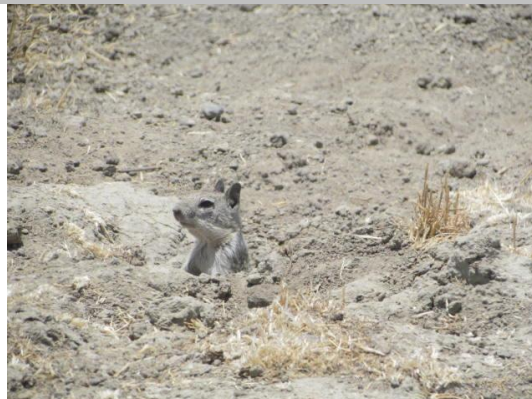
Photo 1 of 1 : SP_2020_NA0010_126_8_20200225_00005.jpg

LM Start	1.38	Rating **	M	Issue No.	8
LM End	1.38	Issue Type +	Ma	Location *	LS
Category	Earthen Levee			GPS Latitude/Longitude	
				Start	End
Item	Animal Control			37.263175 °	37.263175 °
				-120.752307 °	-120.752307 °
DWR ID	DWR_NA0010_08_s_2013_8				
Comment Code					
A1 : Exterminate rodents and backfill and compact or grout burrows.					
Inspector Comment

Looking west at rodent holes on landward slope.

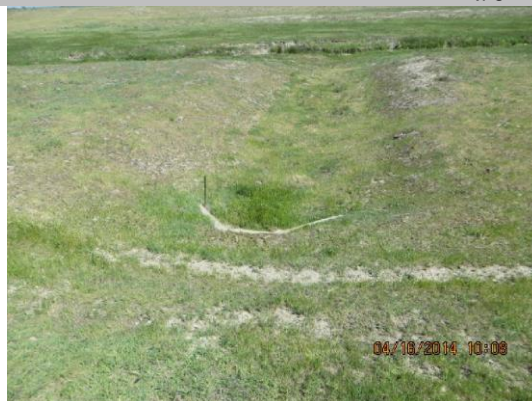
Photo 1 of 3 : UCIP_SP_2020_39510_61094.jpg

Pipe, headwall, and flapgate on WS toe.

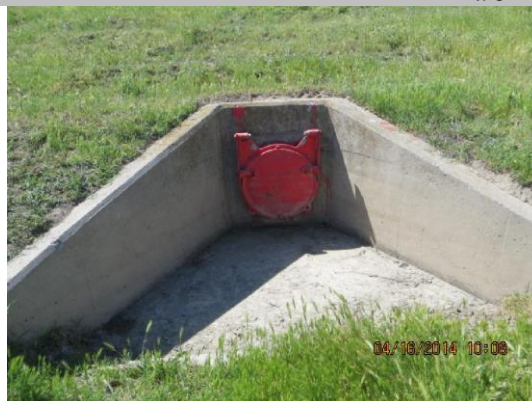
Photo 2 of 3 : UCIP_SP_2020_39510_61093.jpg

Pipe, headwall, and flapgate on WS toe.

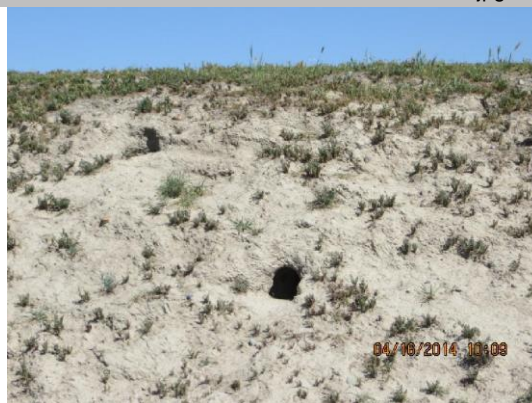
Photo 3 of 3 : UCIP_SP_2020_39510_61095.jpg

Animal burrows along alignment on LS slope.

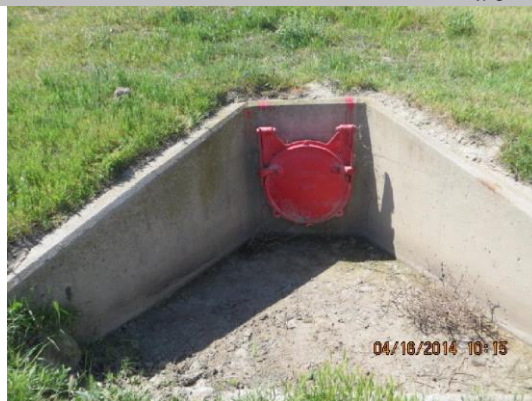
Photo 1 of 3 : UCIP_SP_2020_39511_61098.jpg

Pipe, headwall, and flapgate on Ws toe.

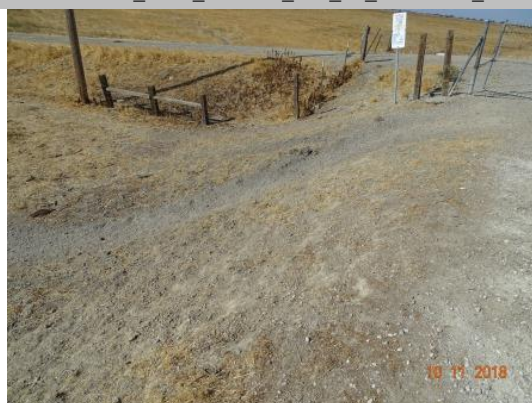
Photo 1 of 1 : SP_2020_NA0010_126_22_20200225_00008.jpg

LM Start	2.07	Rating **	M	Issue No.	22
LM End	2.07	Issue Type +	Ma	Location *	LS
Category	Earthen Levee			GPS Latitude/Longitude	
				Start	End
Item	Animal Control			37.258076 °	37.258076 °
				-120.742439 °	-120.742439 °
DWR ID	DWR_NA0010_08_f_2018_22				
Comment Code					
A2 : Repair the levee slope damaged by livestock and prevent large animal access.					
Inspector Comment					
There is damage to the slope and shoulder from livestock.

Slope and shoulder damage from livestock. (Fall 2018)

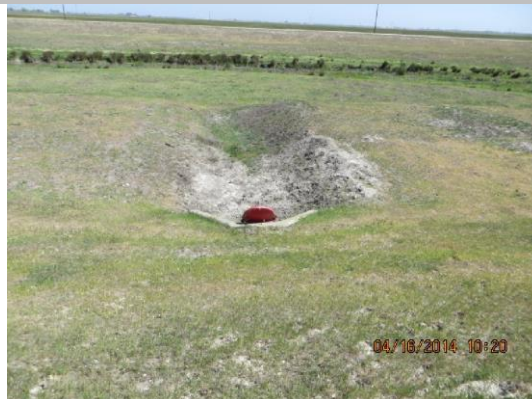
Photo 1 of 3 : UCIP_SP_2020_39512_61102.jpg

Pipe, headwall, and flapgate on WS toe.

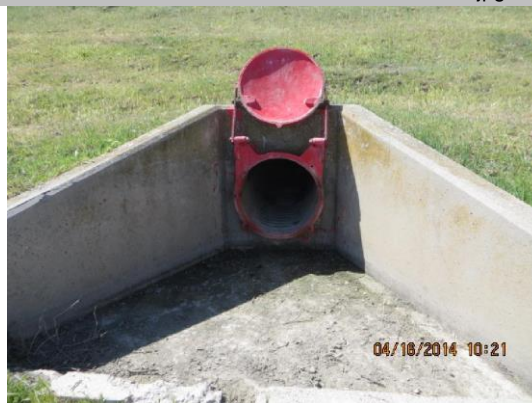
Photo 2 of 3 : UCIP_SP_2020_39512_61100.jpg

Pipe, headwall, and flapgate on WS toe.

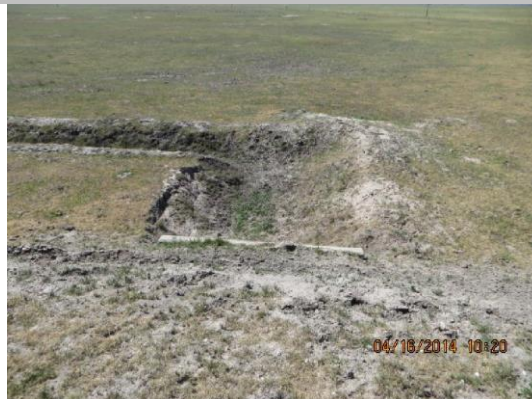
Photo 3 of 3 : UCIP_SP_2020_39512_61101.jpg

Pipe and headwall on LS toe.

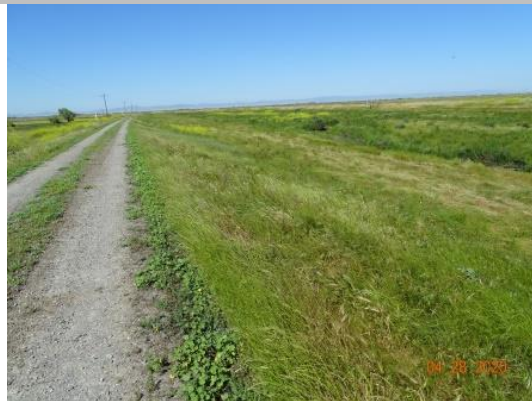
Photo 1 of 1 : SP_2020_NA0010_126_31_20200508_00048.jpg

LM Start	2.24	Rating **	U	Issue No.	31
LM End	3.60	Issue Type +	Ma	Location *	WS
Category	Earthen Levee			GPS Latitude/Longitude	
				Start	End
Item	Vegetation			37.256560 °	37.253897 °
				-120.740162 °	-120.719185 °
DWR ID	DWR_NA0010_08_s_2020_31				
Comment Code					
V1 : Control annual grass and weeds on the levee slopes and easements.					
Inspector Comment

Looking downstream along the waterside slope. (Spring 2020)

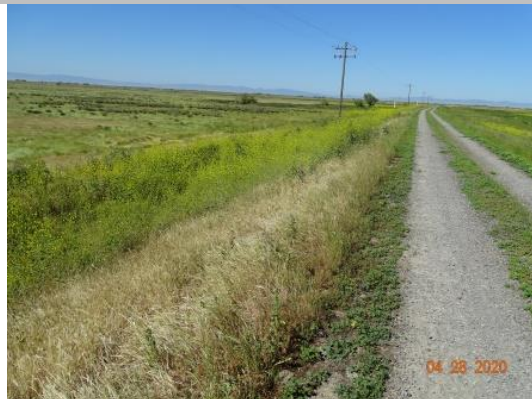
Photo 1 of 1 : SP_2020_NA0010_126_30_20200508_00049.jpg

LM Start	2.70	Rating **	U	Issue No.	30
LM End	3.60	Issue Type +	Ma	Location *	LS
Category	Earthen Levee			GPS Latitude/Longitude	
				Start	End
Item	Vegetation			37.252719 °	37.253899 °
				-120.734131 °	-120.719180 °
DWR ID	DWR_NA0010_08_s_2020_30				
Comment Code					
V1 : Control annual grass and weeds on the levee slopes and easements.					
Inspector Comment

View of vegetation along the landside slope. (Spring 2020)

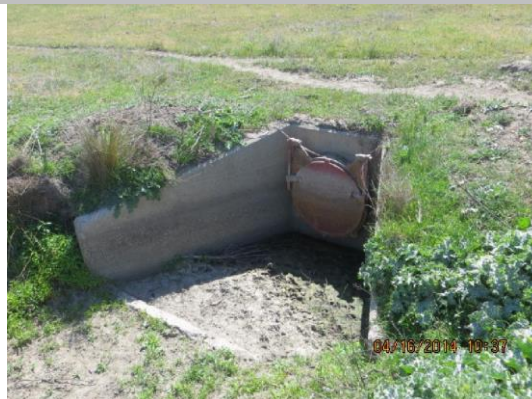
Photo 2 of 3 : UCIP_SP_2020_49969_61113.jpg

Pipe, headwall, and flapgate on WS toe.

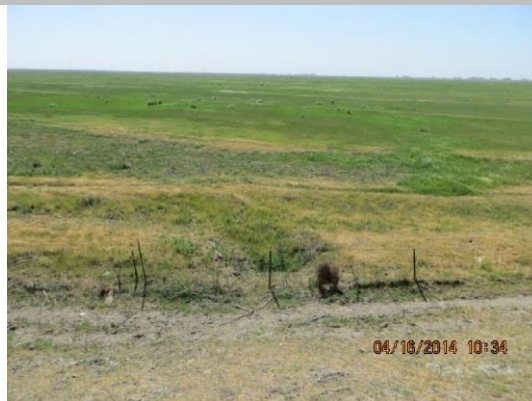
Photo 3 of 3 : UCIP_SP_2020_49969_61111.jpg

Pipe and headwall on LS toe.

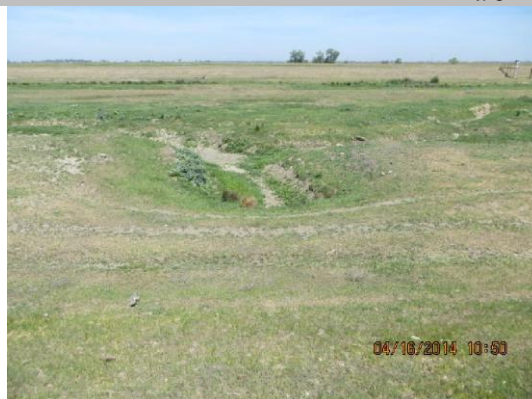
Photo 1 of 3 : UCIP_SP_2020_39513_61134.jpg

Pipe, headwall, and flapgate on WS toe.

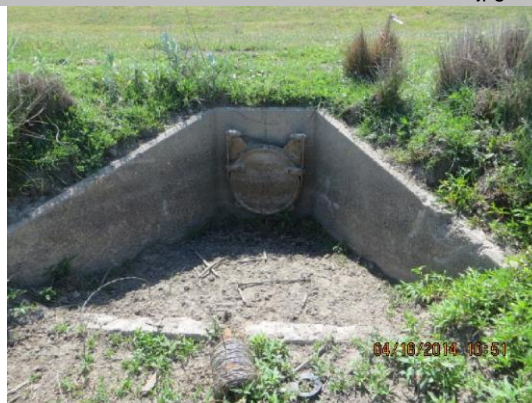
Photo 2 of 3 : UCIP_SP_2020_39513_61133.jpg

Pipe, headwall, and flapgate on WS toe.

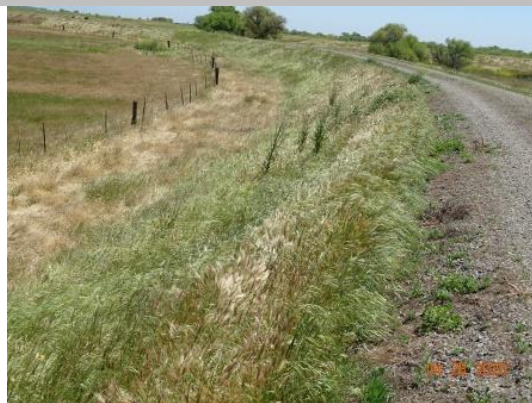
Photo 1 of 1 : SP_2020_NA0010_127_7_20200508_00014.jpg

LM Start	0.08	Rating **	U	Issue No.	7
LM End	0.41	Issue Type +	Ma	Location *	LS
Category	Earthen Levee			GPS Latitude/Longitude	
				Start	End
Item	Vegetation			37.219541 °	37.220077 °
				-120.711973 °	-120.706242 °
DWR ID	DWR_NA0010_09_s_2020_7				
Comment Code					
V1 : Control annual grass and weeds on the levee slopes and easements.					
Inspector Comment

Looking downstream along the landside slope. (Spring 2020)

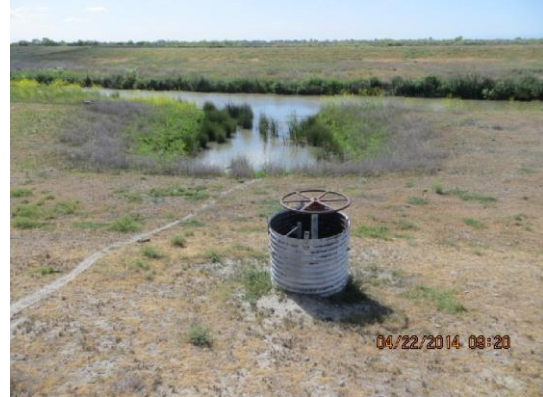
Photo 1 of 3 : UCIP_SP_2020_39888_62119.jpg

Comment Code						
Inspector Comment						
DS_ID:19841 FS_ID:39888 EP_NO: N/A Repair Type: Non-Urgent Crossing Status: Found UCIP Comments: 04/22/2014 Concrete headwalls on landward and waterward under water. Need photo to confirm condition of concrete headwalls, pipe, and gate on both toes. (DWR UCIP - W. Wylie) FIELD_STRUCT_DESC: 24-inch corrugated metal gravity drainage pipe through the levee, 18.7 feet below the crown. Slide gate in a 36-inch corrugated metal pipe (CMP) riser on the waterside (WS) slope. Concrete U-shaped headwall on each end. [Additional Reference(s): DWR Levee Log, 2002. USACE San Joaquin O&M Manual 601.1, 1967, (HLM 0.47)]. FS Date: 4/22/2014

Slide gate in CMP riser on WS slope with outlet visible in background.

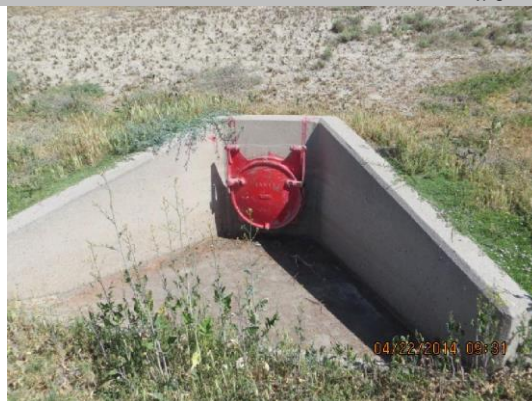
Photo 2 of 3 : UCIP_SP_2020_39515_62132.jpg

Headwall, flapgate, and pipe on WS toe.

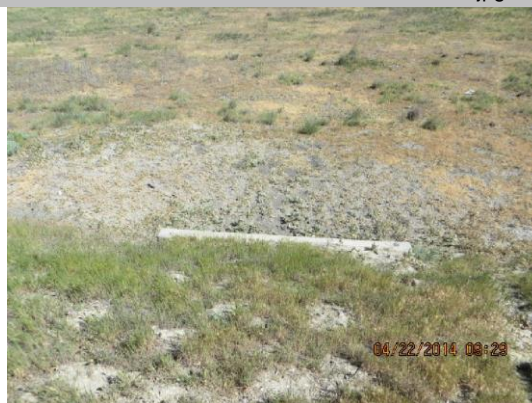
Photo 3 of 3 : UCIP_SP_2020_39515_62129.jpg

Headwall and pipe on LS toe.

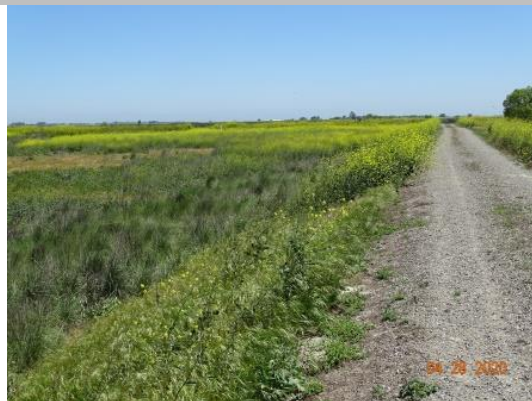
Photo 1 of 1 : SP_2020_NA0010_127_10_20200508_00016.jpg

LM Start	0.76	Rating **	U	Issue No.	10
LM End	0.86	Issue Type +	Ma	Location *	LS
Category	Earthen Levee			GPS Latitude/Longitude	
				Start	End
Item	Vegetation			37.219793 °	37.220035 °
				-120.700205 °	-120.698451 °
DWR ID	DWR_NA0010_09_s_2020_10				
Comment Code					
V1 : Control annual grass and weeds on the levee slopes and easements.					
Inspector Comment

View of landside slope looking downstream. (Spring 2020)

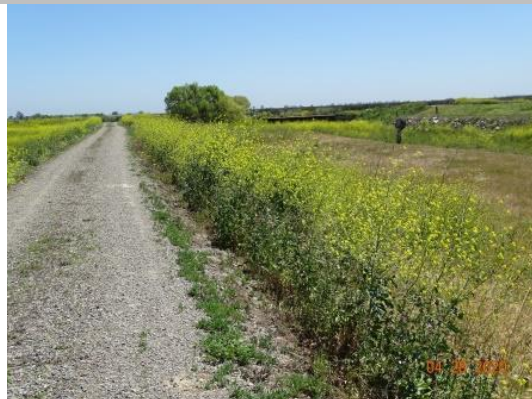
Photo 1 of 1 : SP_2020_NA0010_127_11_20200508_00015.jpg

LM Start	0.76	Rating **	U	Issue No.	11
LM End	0.86	Issue Type +	Ma	Location *	WS
Category	Earthen Levee			GPS Latitude/Longitude	
				Start	End
Item	Vegetation			37.219793 °	37.220035 °
				-120.700205 °	-120.698451 °
DWR ID	DWR_NA0010_09_s_2020_11				
Comment Code					
V1 : Control annual grass and weeds on the levee slopes and easements.					
Inspector Comment

Looking downstream along the waterside slope. (Spring 2020)

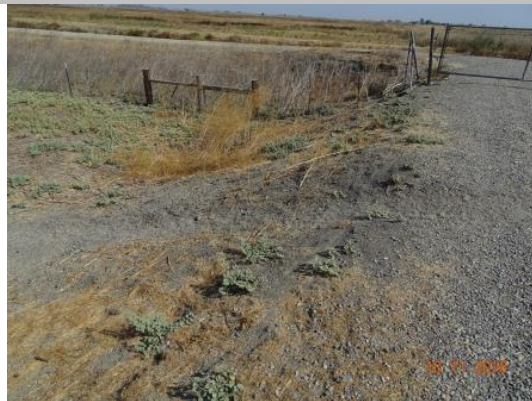
Photo 1 of 1 : SP_2020_NA0010_127_4_20200225_00001.jpg

LM Start	0.86	Rating **	M	Issue No.	4
LM End	0.86	Issue Type +	Ma	Location *	LS
Category	Earthen Levee			GPS Latitude/Longitude	
				Start	End
Item	Animal Control			37.220041 °	37.220041 °
				-120.698425 °	-120.698425 °
DWR ID	DWR_NA0010_09_f_2017_4				
Comment Code					
A2 : Repair the levee slope damaged by livestock and prevent large animal access.					
Inspector Comment

View of slope erosion due to foot traffic. (Fall 2018)

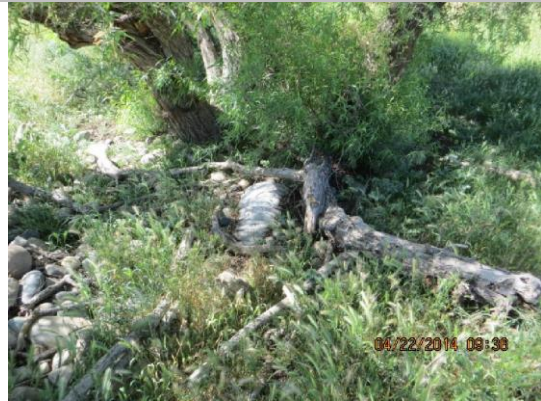
Photo 3 of 3 : UCIP_SP_2020_34186_62137.jpg

Outlet at WS toe.

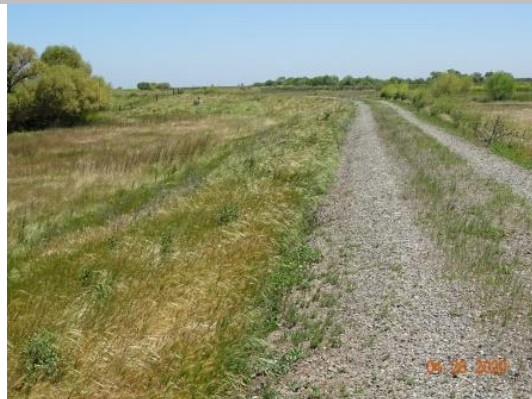
Photo 1 of 1 : SP_2020_NA0010_128_7_20200508_00006.jpg

LM Start	0.00	Rating **	U	Issue No.	7
LM End	0.29	Issue Type +	Ma	Location *	WS
Category	Earthen Levee			GPS Latitude/Longitude	
				Start	End
Item	Vegetation			37.217793 °	37.219078 °
				-120.711467 °	-120.706747 °
DWR ID	DWR_NA0010_10_s_2020_7				
Comment Code					
V1 : Control annual grass and weeds on the levee slopes and easements.					
Inspector Comment

View of vegetation along the waterside slope. (Spring 2020)

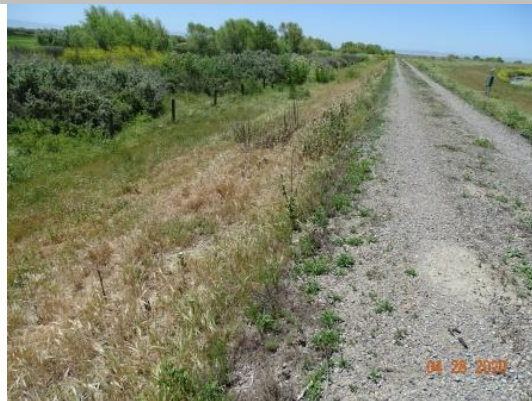
Photo 1 of 1 : SP_2020_NA0010_128_4_20200508_00007.jpg

LM Start	0.00	Rating **	M	Issue No.	4
LM End	0.76	Issue Type +	Ma	Location *	LS
Category	Earthen Levee			GPS Latitude/Longitude	
				Start	End
Item	Vegetation			37.217793 °	37.219258 °
				-120.711467 °	-120.698624 °
DWR ID	DWR_NA0010_10_s_2020_4				
Comment Code					
V1 : Control annual grass and weeds on the levee slopes and easements.					
Inspector Comment

Looking downstream along the landside slope. (Spring 2020)

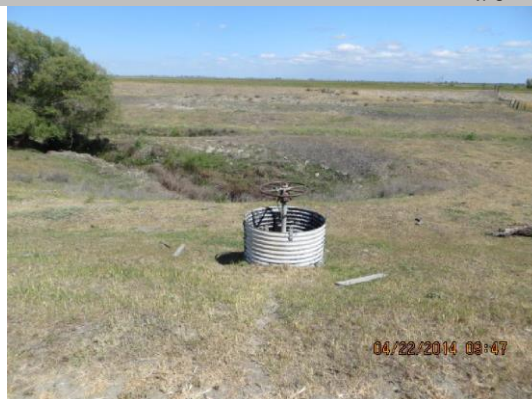
Photo 1 of 3 : UCIP_SP_2020_39516_62144.jpg

LM Start	0.30	Rating **	M	Issue No.	8	
LM End	0.30	Issue Type +	Ma	Location *		
Category	Supplemental			GPS Latitude/Longitude		
				Start		End
Item	DWR UCIP LMA Responsibility			37.219116 °	37.219116 °	
				-120.706652 °	-120.706652 °	
DWR ID	19845					
Comment Code						
Inspector Comment						
DS_ID:19845 FS_ID:39516 EP_NO: N/A Repair Type: Non-Urgent Crossing Status: Found UCIP Comments: 04/22/2014 Inlet blocked at LS toe by wooden gate. Need to contact owner to determine status. (DWR UCIP - W. Wylie) FIELD_STRUCT_DESC: 36-inch corrugated metal gravity drainage pipe through the levee, 19.6 feet below the crown. Slide gate in a 48-inch corrugated metal pipe (CMP) riser on the waterside (WS) slope. Concrete U-shaped headwall on each end. [Additional Reference(s): DWR Levee Log, 2002. USACE San Joaquin O&M Manual 601.1, 1967, (HLM 0.31)]. FS Date: 4/22/2014

Headwall and pipe visible on LS toe. Slide gate inside 48-inch CMP riser on WS slope.

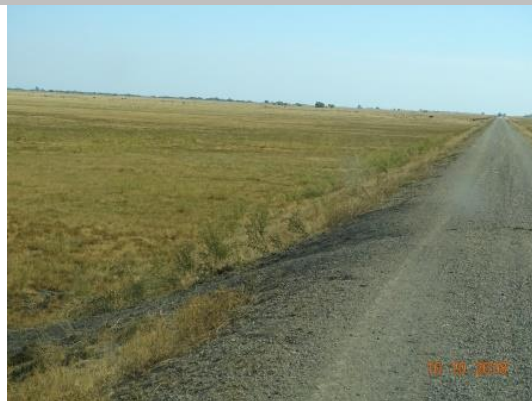
Photo 1 of 1 : SP_2020_NA0010_129_11_20200225_00004.jpg

LM Start	0.21	Rating **	M	Issue No.	11
LM End	0.21	Issue Type +	Ma	Location *	LS
Category	Earthen Levee			GPS Latitude/Longitude	
				Start	End
Item	Animal Control			37.202731 °	37.202731 °
				-120.751389 °	-120.751389 °
DWR ID	DWR_NA0010_11_f _ 2018_11				
Comment Code					
A2 : Repair the levee slope damaged by livestock and prevent large animal access.					
Inspector Comment					
Damage is from livestock on the landside slope.

View of slope damage on landside. (Fall 2018)

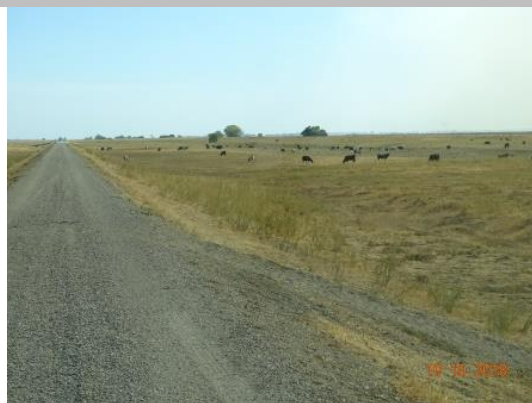
Photo 1 of 1 : SP_2020_NA0010_129_13_20200520_00034.jpg

LM Start	0.21	Rating **	M	Issue No.	13
LM End	0.21	Issue Type +	Ma	Location *	WS
Category	Earthen Levee			GPS Latitude/Longitude	
				Start	End
Item	Animal Control			37.202731 °	37.202731 °
				-120.751389 °	-120.751389 °
DWR ID	DWR_NA0010_11_s_2020_13				
Comment Code					
A2 : Repair the levee slope damaged by livestock and prevent large animal access.					
Inspector Comment					
Damage to the levee slope from livestock traffic.

View of damage on waterside shoulder and slope. (Fall 2018)

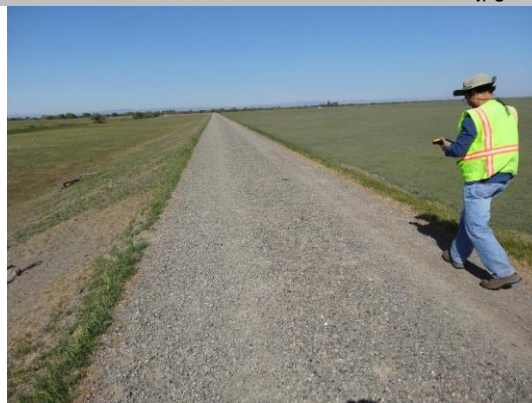
Photo 2 of 3 : UCIP_SP_2020_39517_66643.jpg

View of levee crown at crossing.

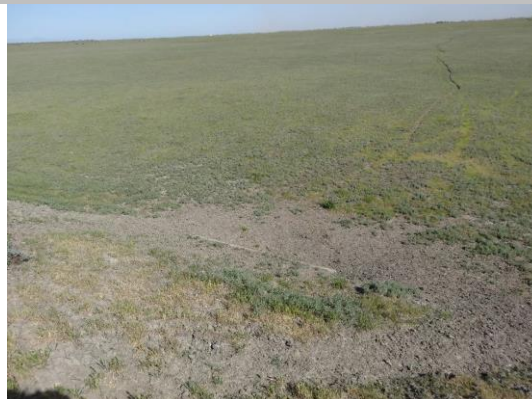
Photo 3 of 3 : UCIP_SP_2020_39517_66642.jpg

View of landward side.

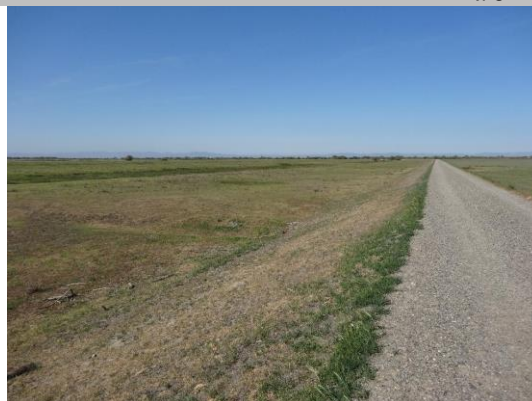
Photo 1 of 3 : UCIP_SP_2020_39518_61997.jpg

DS_ID:19847
 FS_ID:39518
 EP_NO: N/A
 Repair Type: Non-Urgent
 Crossing Status: Found
 UCIP Comments: 04/18/2014 Need to contact owner. Recommend clearing sediment deposit inside pipe. (DWR UCIP - O. Magana)
 FIELD_STRUCT_DESC: 24-inch corrugated metal gravity drainage pipe through the levee, 10 feet below the crown. Flap gate on the waterside (WS) end. [Additional Reference(s): DWR Levee Log, 2002. USACE San Joaquin O&M Manual 601.1, 1967, (HLM 0.65)].
 FS Date: 4/18/2014

View of waterward side.

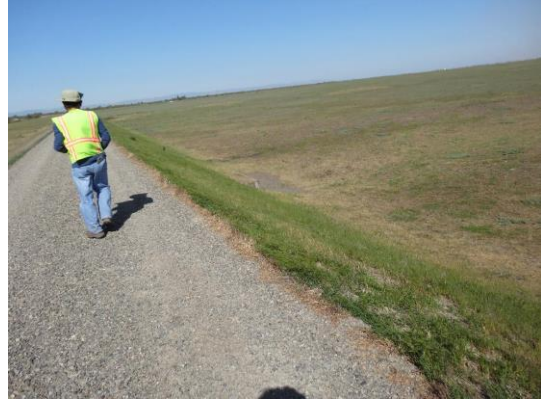
Photo 2 of 3 : UCIP_SP_2020_39518_61996.jpg

View of landward side.

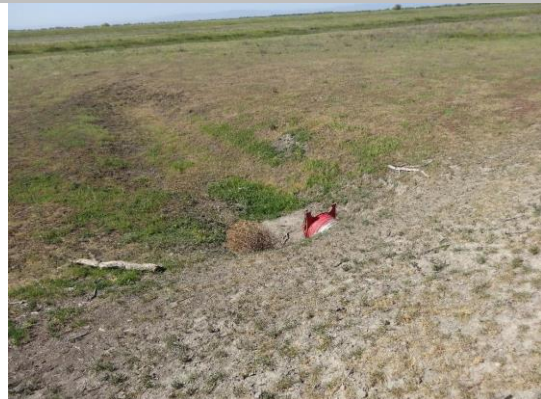
Photo 3 of 3 : UCIP_SP_2020_39518_61999.jpg

Flap gate and concrete apron located on waterward side.

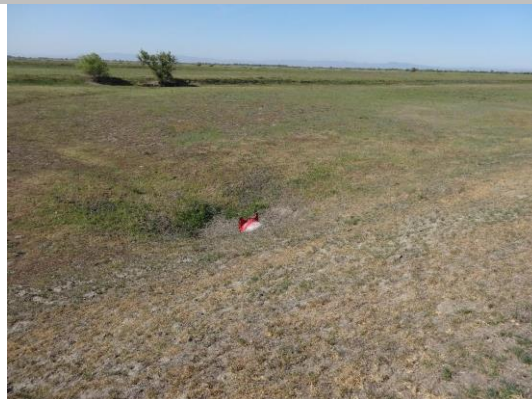
Photo 1 of 3 : UCIP_SP_2020_39519_62003.jpg

LM Start	0.84	Rating **	M	Issue No.	25
LM End	0.84	Issue Type +	Ma	Location *	
Category	Supplemental			GPS Latitude/Longitude	
				Start	End
Item	DWR UCIP LMA Responsibility			37.202745 °	37.202745 °
				-120.739935 °	-120.739935 °
DWR ID	19848				
Comment Code					
Inspector Comment					
DS_ID:19848 FS_ID:39519 EP_NO: N/A Repair Type: Non-Urgent Crossing Status: Found UCIP Comments: 04/18/2014 Need to contact owner. Recommend clearing sediment deposit inside pipe. (DWR UCIP - O. Magana) FIELD_STRUCT_DESC: 24-inch corrugated metal gravity drainage pipe through the levee, 10.3 feet below the crown. Flap gate on the waterside (WS) end. [Additional Reference(s): DWR Levee Log, 2002. USACE San Joaquin O&M Manual 601.1, 1967, (HLM 0.84)]. FS Date: 4/18/2014

Overview of waterward side.

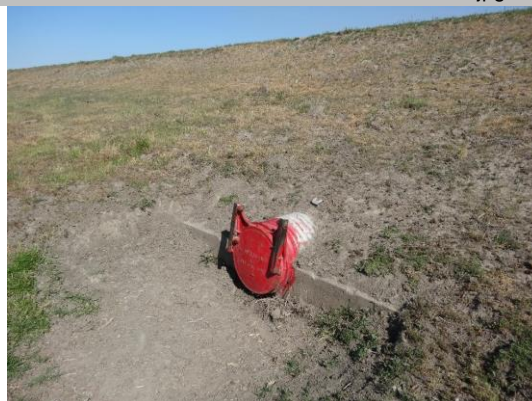
Photo 2 of 3 : UCIP_SP_2020_39519_62002.jpg

Concrete headwall and flap gate visible on waterward side.

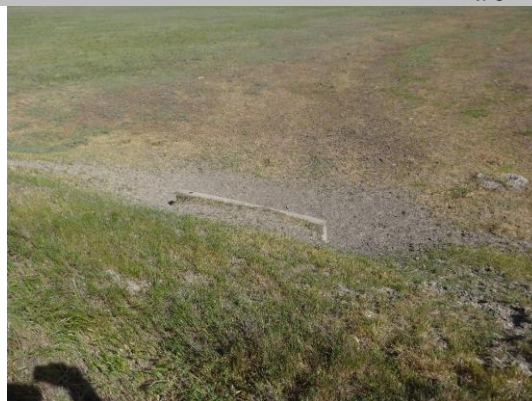
Photo 3 of 3 : UCIP_SP_2020_39519_62001.jpg

View of landward side.

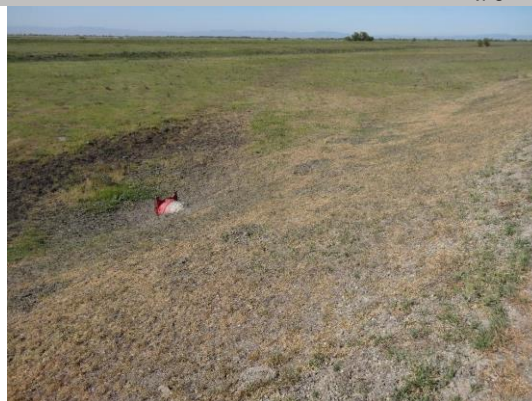
Photo 1 of 3 : UCIP_SP_2020_39520_62008.jpg

DS_ID:19849
 FS_ID:39520
 EP_NO: N/A
 Repair Type: Non-Urgent
 Crossing Status: Found
 UCIP Comments: 04/18/2014 Need to contact owner. Recommend clearing sediment deposit inside pipe. (DWR UCIP - O. Magana)
 FIELD_STRUCT_DESC: 24-inch corrugated metal gravity drainage pipe through the levee, 9 feet below the crown. Flap gate on the waterside (WS) end. [Additional Reference(s): DWR Levee Log, 2002. USACE San Joaquin O&M Manual 601.1, 1967, (HLM 1.13)].
 FS Date: 4/18/2014

View of waterward side--flap gate visible at levee toe.

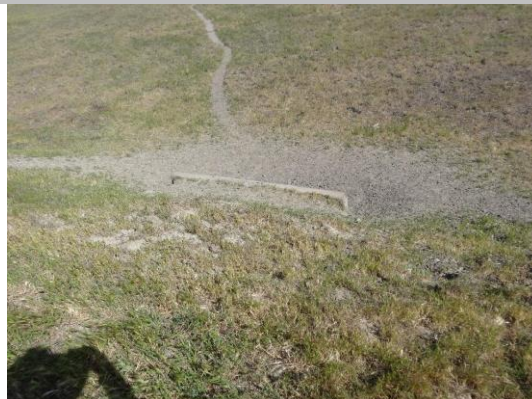
Photo 2 of 3 : UCIP_SP_2020_39520_62007.jpg

View of landward side.

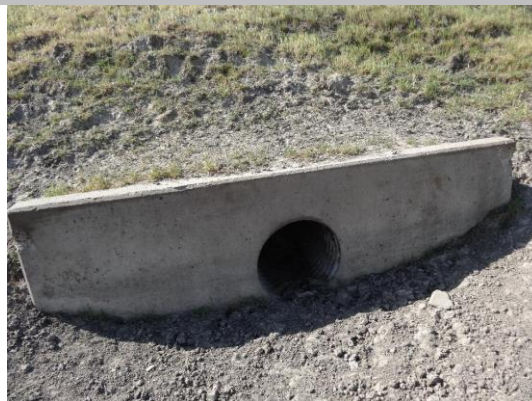
Photo 3 of 3 : UCIP_SP_2020_39520_62006.jpg

Concrete headwall located on landward side.

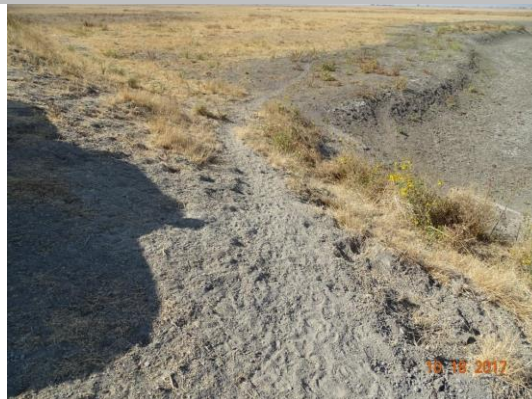
Photo 1 of 1 : SP_2020_NA0010_129_9_20200225_00001.jpg

LM Start	1.49	Rating **	A/W	Issue No.	9
LM End	1.49	Issue Type +	Ma	Location *	LS
Category	Earthen Levee			GPS Latitude/Longitude	
				Start	End
Item	Animal Control			37.202748 °	37.202748 °
				-120.728182 °	-120.728182 °
DWR ID	DWR_NA0010_11_f _ 2017_9				
Comment Code					
A2 : Repair the levee slope damaged by livestock and prevent large animal access.					
Inspector Comment

Looking northwest at landside slope.

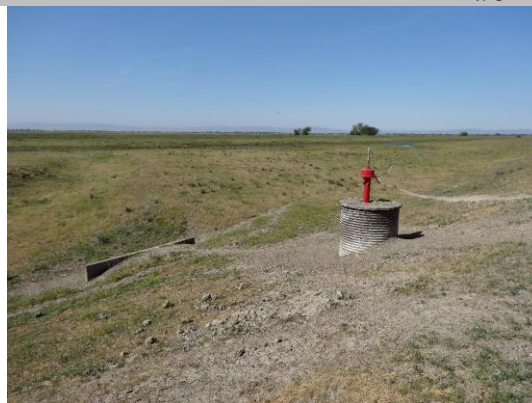
Photo 1 of 3 : UCIP_SP_2020_39521_62018.jpg

LM Start	1.49	Rating **	M	Issue No.	27
LM End	1.49	Issue Type +	Ma	Location *	
Category	Supplemental			GPS Latitude/Longitude	
				Start	End
Item	DWR UCIP LMA Responsibility			37.202753 °	37.202753 °
				-120.728133 °	-120.728133 °
DWR ID	19850				
Comment Code					
Inspector Comment					
DS_ID:19850 FS_ID:39521 EP_NO: N/A Repair Type: Non-Urgent Crossing Status: Found UCIP Comments: 04/18/2014 Need to contact owner. Recommend clearing sediment deposit inside pipe. (DWR UCIP - O. Magana) FIELD_STRUCT_DESC: 48-inch corrugated metal gravity drainage pipe through the levee, 16.3 feet below the crown. Slide gate in a pipe riser on the waterside (WS) slope. [Additional Reference(s): DWR Levee Log, 2002. USACE San Joaquin O&M Manual 601.1, 1967, (HLM 1.50)]. FS Date: 4/18/2014

View of waterward side.

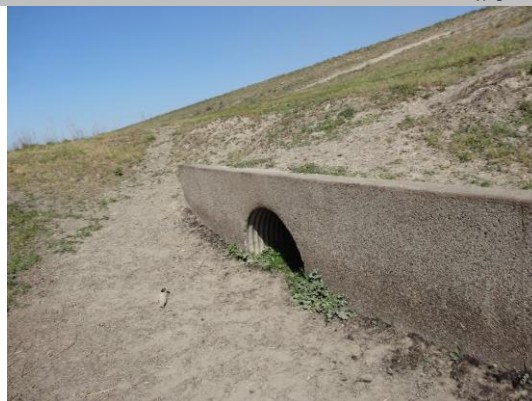
Photo 2 of 3 : UCIP_SP_2020_39521_62017.jpg

View of concrete headwall located on waterward side.

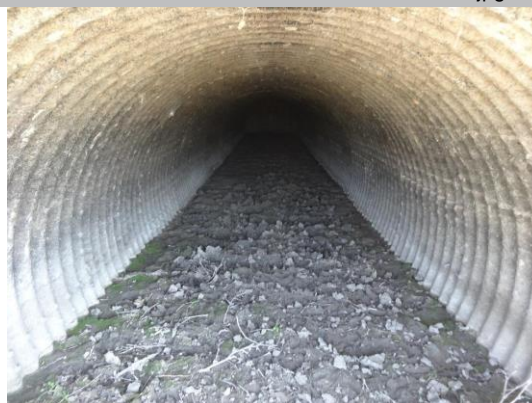
Photo 3 of 3 : UCIP_SP_2020_39521_62016.jpg

Inside view of pipe from waterward side--sediment build up.

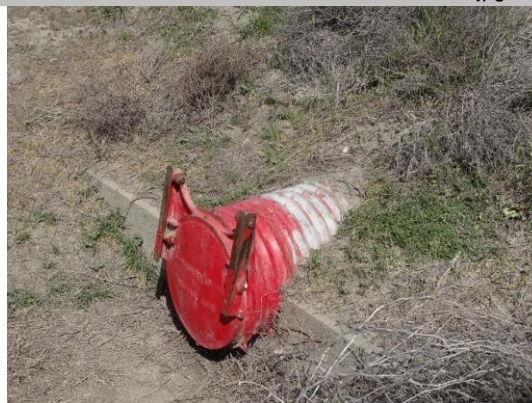
Photo 2 of 3 : UCIP_SP_2020_39522_62025.jpg

Flap gate located on waterward side.

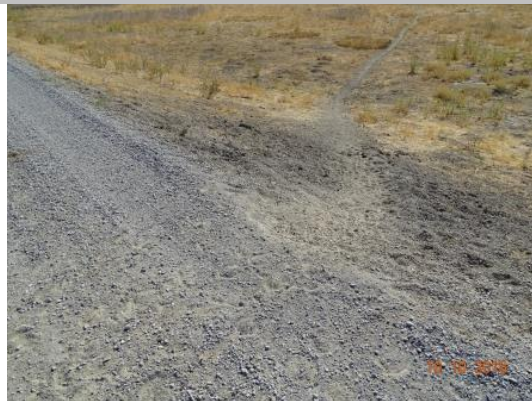
Photo 2 of 2 : SP_2020_NA0010_129_12_20200225_00007.jpg

View of waterside slope. (Fall 2018)

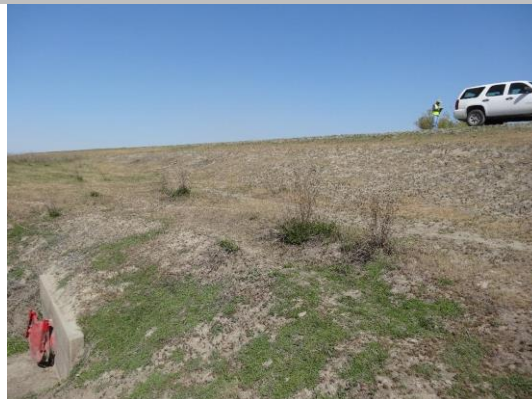
Photo 1 of 3 : UCIP_SP_2020_39523_62028.jpg

LM Start	3.04	Rating **	M	Issue No.	29
LM End	3.04	Issue Type +	Ma	Location *	
Category	Supplemental			GPS Latitude/Longitude	
				Start	End
Item	DWR UCIP LMA Responsibility			37.202494 °	37.202494 °
				-120.700153 °	-120.700153 °
DWR ID	19852				
Comment Code					
Inspector Comment					
DS_ID:19852 FS_ID:39523 EP_NO: N/A Repair Type: Non-Urgent Crossing Status: Found UCIP Comments: 04/18/2014 Need to contact owner. Recommend clearing sediment deposit inside pipe. (DWR UCIP - O. Magana) FIELD_STRUCT_DESC: 24-inch corrugated metal gravity drainage pipe through the levee, 15 feet below the crown. Flap gate on the waterside (WS) end. [Additional Reference(s): DWR Levee Log, 2002. USACE San Joaquin O&M Manual 601.1, 1967, (HLM 3.04)]. FS Date: 4/18/2014

Overview of waterward side--flap gate, concrete headwall and apron visible on levee toe.

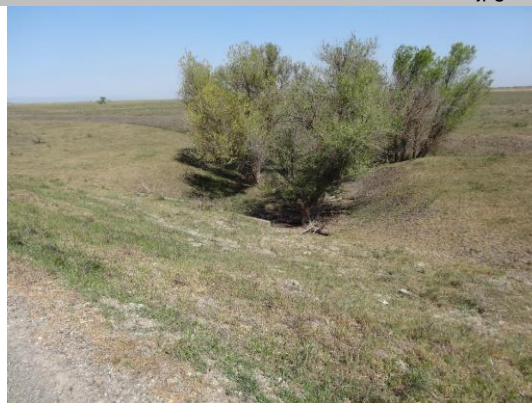
Photo 2 of 3 : UCIP_SP_2020_39523_62027.jpg

View of landward side.

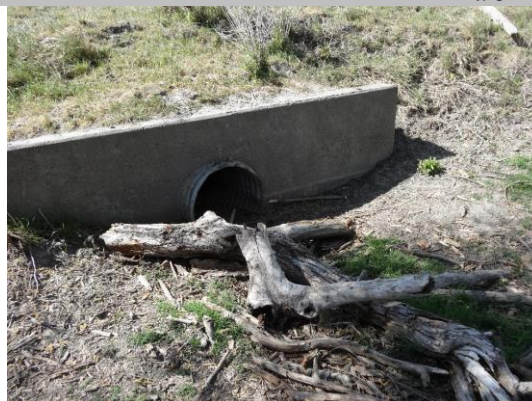
Photo 3 of 3 : UCIP_SP_2020_39523_62030.jpg

Concrete headwall located on landward side--debris in front of headwall.

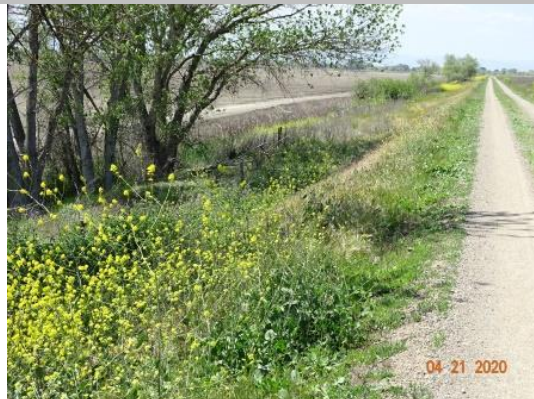
Photo 1 of 1 : SP_2020_NA0010_130_18_20200508_00024.jpg

LM Start	0.02	Rating **	U	Issue No.	18
LM End	1.23	Issue Type +	Ma	Location *	LS
Category	Earthen Levee			GPS Latitude/Longitude	
				Start	End
Item	Vegetation			37.200943 °	37.200910 °
				-120.754865 °	-120.732938 °
DWR ID	DWR_NA0010_12_s_2020_18				
Comment Code					
V1 : Control annual grass and weeds on the levee slopes and easements.					
Inspector Comment

View of the landside slope looking downstream. (Spring 2020)

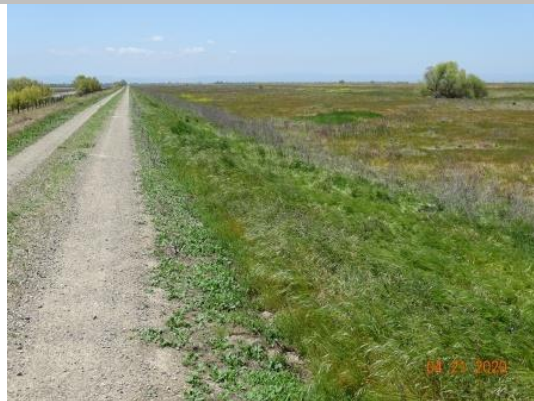
Photo 1 of 1 : SP_2020_NA0010_130_15_20200508_00025.jpg

LM Start	0.02	Rating **	U	Issue No.	15
LM End	2.66	Issue Type +	Ma	Location *	WS
Category	Earthen Levee			GPS Latitude/Longitude	
				Start	End
Item	Vegetation			37.200943 °	37.200902 °
				-120.754846 °	-120.707024 °
DWR ID	DWR_NA0010_12_s_2020_15				
Comment Code					
V1 : Control annual grass and weeds on the levee slopes and easements.					
Inspector Comment

Vegetation growing on the waterside slope. (Spring 2020)

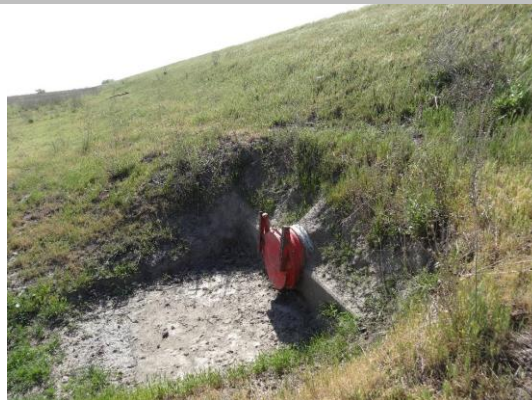
Photo 2 of 3 : UCIP_SP_2020_36704_66649.jpg

Concrete headwall and flap gate visible on waterward side.

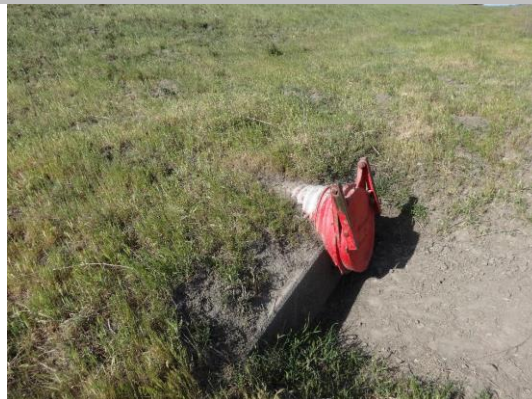
Photo 2 of 3 : UCIP_SP_2020_39889_62049.jpg

Concrete headwall and flap gate visible on waterward side.

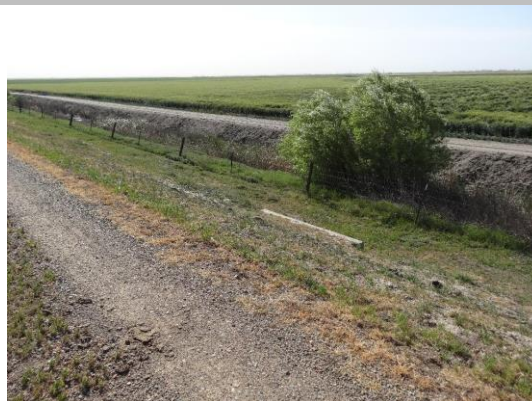
Photo 3 of 3 : UCIP_SP_2020_39889_62047.jpg

View of landward side.

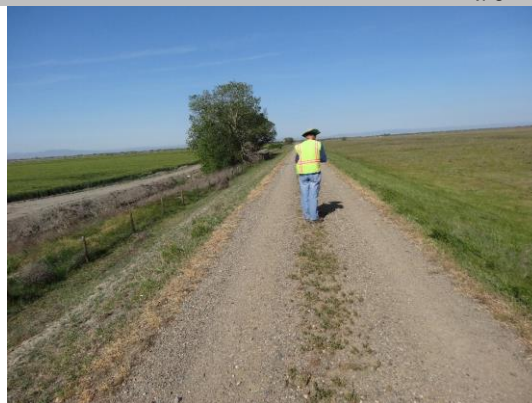
Photo 1 of 3 : UCIP_SP_2020_36705_66654.jpg

Comment Code						
Inspector Comment						
DS_ID:19857 FS_ID:36705 EP_NO: N/A Repair Type: Non-Urgent Crossing Status: Found UCIP Comments: 04/18/2014 Landward side not accessible due to dense vegetation and fence. Concrete headwall and flap gate under water therefore not able to evaluate condition. Will need to coordinate with owner to evaluate condition of crossing on waterward side and obtain access to evaluate landward side. (DWR UCIP - O. Magana) FIELD_STRUCT_DESC: 24-inch corrugated metal gravity drainage pipe through the levee, 17.4 feet below the crown. Flap gate on the waterside (WS) end. [Additional Reference(s): DWR Levee Log, 2002. USACE San Joaquin O&M Manual 601.1, 1967, (HLM 1.27)]. FS Date: 4/18/2014

Overview of levee crown at crossing.

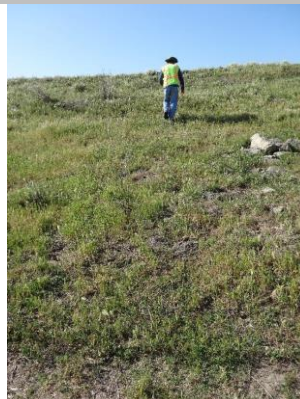
Photo 2 of 3 : UCIP_SP_2020_36705_66652.jpg

View of waterward slope.

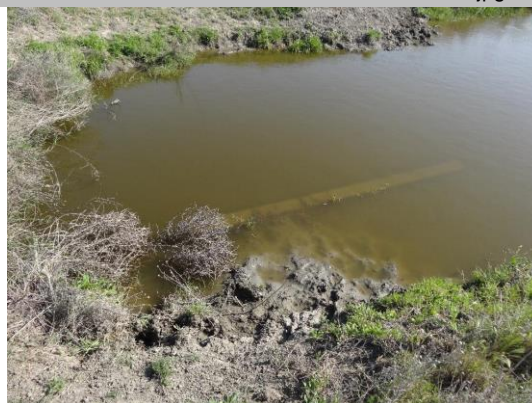
Photo 3 of 3 : UCIP_SP_2020_36705_66653.jpg

View of concrete wall underwater.

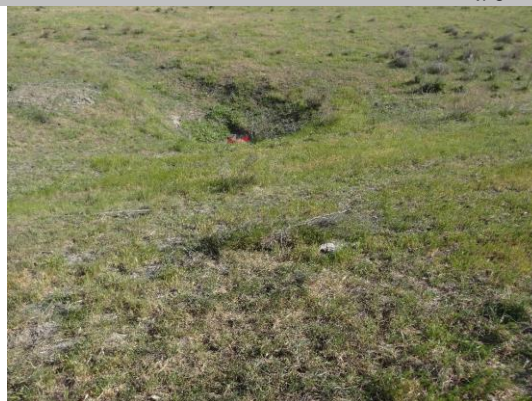
Photo 1 of 3 : UCIP_SP_2020_34126_62060.jpg

LM Start	1.53	Rating **	M	Issue No.	22
LM End	1.53	Issue Type +	Ma	Location *	
Category	Supplemental			GPS Latitude/Longitude	
				Start	End
Item	DWR UCIP LMA Responsibility			37.200913 °	37.200913 °
				-120.727496 °	-120.727496 °
DWR ID	19858				
Comment Code					
Inspector Comment					
DS_ID:19858 FS_ID:34126 EP_NO: N/A Repair Type: Non-Urgent Crossing Status: Found UCIP Comments: 04/18/2014 Limited access on landward side due to fence and dense vegetation. Recommend obtaining access to landward side and clear vegetation on landward side. (DWR UCIP - O. Magana) FIELD_STRUCT_DESC: 24-inch corrugated metal gravity drainage pipe through the levee, 10.7 feet below the crown. Flap gate on the waterside (WS) end. [Additional Reference(s): DWR Levee Log, 2002. USACE San Joaquin O&M Manual 601.1, 1967, (HLM 1.53)]. FS Date: 4/18/2014

View of waterward side.

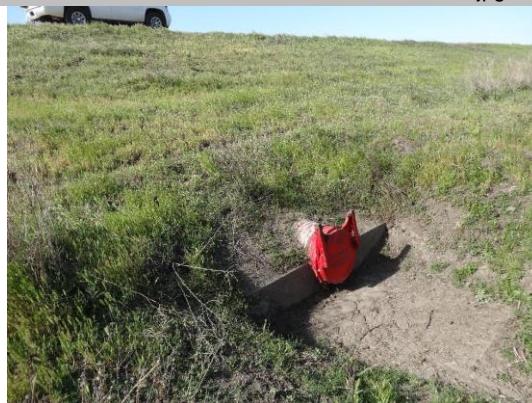
Photo 2 of 3 : UCIP_SP_2020_34126_62061.jpg

Concrete headwall and flap gate visible on waterward side.

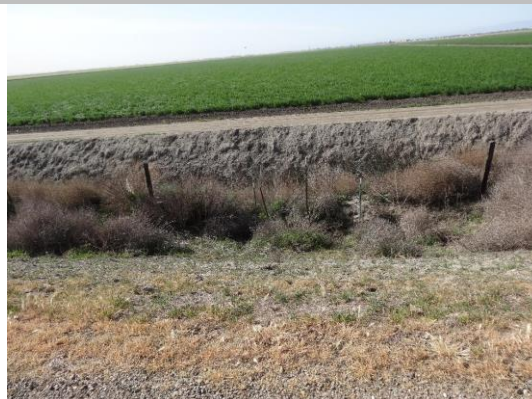
Photo 3 of 3 : UCIP_SP_2020_34126_62059.jpg

View of landward side--limited access due to fence.

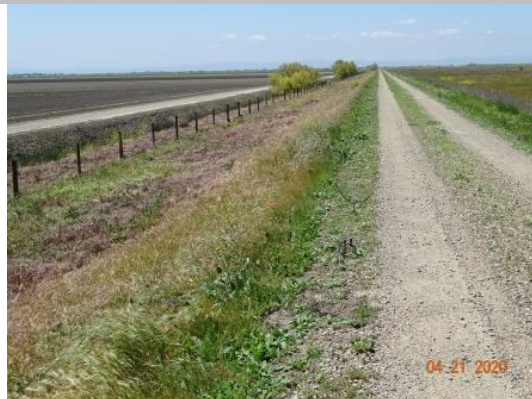
Photo 1 of 1 : SP_2020_NA0010_130_13_20200508_00026.jpg

LM Start	1.67	Rating **	U	Issue No.	13
LM End	2.66	Issue Type +	Ma	Location *	LS
Category	Earthen Levee			GPS Latitude/Longitude	
				Start	End
Item	Vegetation			37.200908 °	37.200902 °
				-120.724876 °	-120.707024 °
DWR ID	DWR_NA0010_12_s_2020_13				
Comment Code					
V1 : Control annual grass and weeds on the levee slopes and easements.					
Inspector Comment

Looking downstream along the landside slope. (Spring 2020)

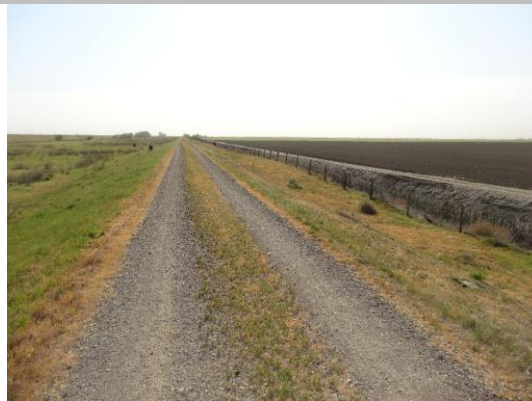
Photo 2 of 3 : UCIP_SP_2020_39506_62063.jpg

Overview of levee crown at crossing.

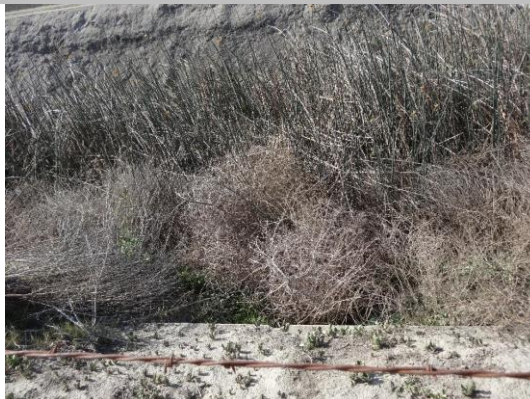
Photo 3 of 3 : UCIP_SP_2020_39506_62062.jpg

Dense vegetation on landward side--limited access due to fence along landward side.

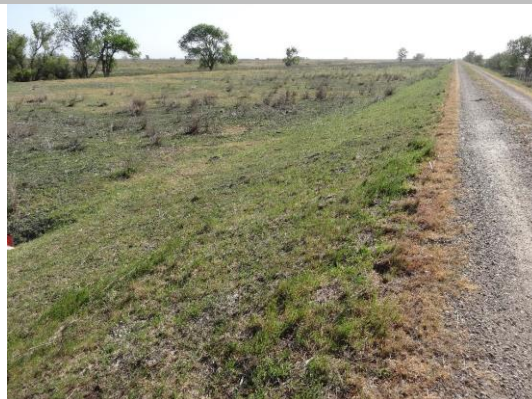
Photo 1 of 3 : UCIP_SP_2020_39890_62069.jpg

LM Start	2.70	Rating **	M	Issue No.	24
LM End	2.70	Issue Type +	Ma	Location *	
Category	Supplemental			GPS Latitude/Longitude	
				Start	End
Item	DWR UCIP LMA Responsibility			37.200906 °	37.200906 °
				-120.706316 °	-120.706316 °
DWR ID	19860				
Comment Code					
Inspector Comment					
DS_ID:19860 FS_ID:39890 EP_NO: N/A Repair Type: Non-Urgent Crossing Status: Found UCIP Comments: 04/18/2014 Need to contact owner. Recommend clearing sediment deposit inside pipe. (DWR UCIP - O. Magana) FIELD_STRUCT_DESC: 24-inch corrugated metal gravity drainage pipe through the levee, 10.7 feet below the crown. Flap gate on the waterside (WS) end. [Additional Reference(s): DWR Levee Log, 2002. USACE San Joaquin O&M Manual 601.1, 1967, (HLM 2.70)]. FS Date: 4/18/2014

View of waterward side.

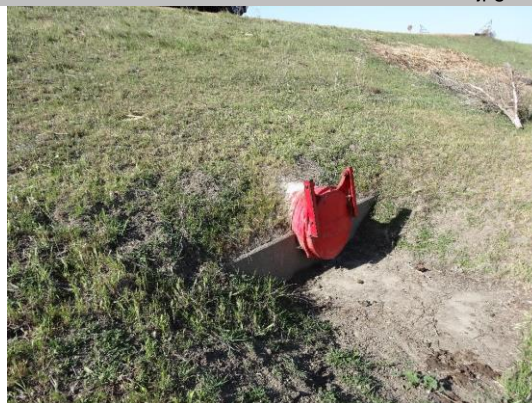
Photo 2 of 3 : UCIP_SP_2020_39890_62070.jpg

Concrete headwall and flat gate located on waterward side.

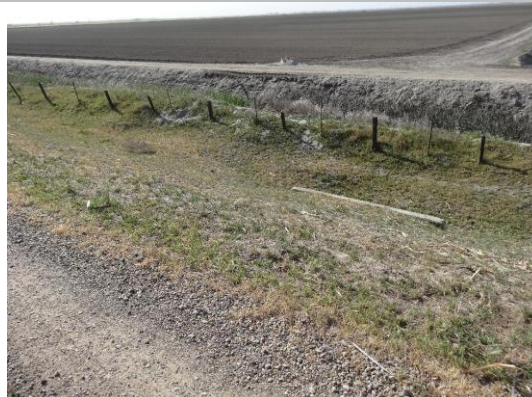
Photo 3 of 3 : UCIP_SP_2020_39890_62068.jpg

View of landward side.

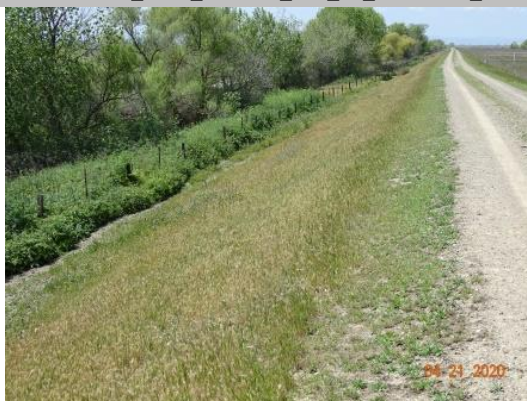
Photo 1 of 1 : SP_2020_NA0010_130_12_20200508_00027.jpg

LM Start	3.03	Rating **	M	Issue No.	12
LM End	3.32	Issue Type +	Ma	Location *	LS
Category	Earthen Levee			GPS Latitude/Longitude	
				Start	End
Item	Vegetation			37.200928 °	37.200952 °
				-120.700366 °	-120.695126 °
DWR ID	DWR_NA0010_12_s_2020_12				
Comment Code					
V1 : Control annual grass and weeds on the levee slopes and easements.					
Inspector Comment

View of the landside slope looking downstream. (Spring 2020)

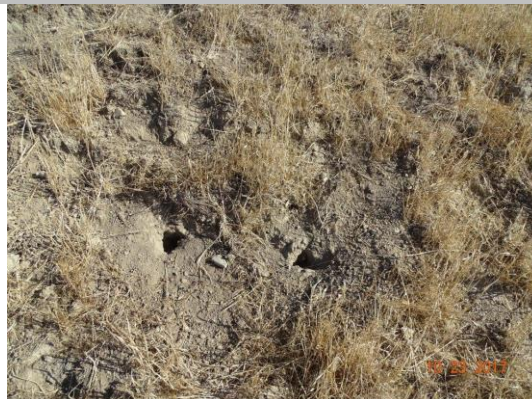
Photo 1 of 1 : SP_2020_NA0010_131_3_20200225_00001.jpg

LM Start	0.15	Rating **	M	Issue No.	3
LM End	0.15	Issue Type +	Ma	Location *	LS
Category	Earthen Levee			GPS Latitude/Longitude	
				Start	End
Item	Animal Control			37.035760 °	37.035760 °
				-120.441282 °	-120.441282 °
DWR ID	DWR_NA0010_13_s_2012_3				
Comment Code					
A3 : No rodents visible, but rodent burrows visible; need to backfill and compact or grout burrows.					
Inspector Comment

Looking at the landside slope.

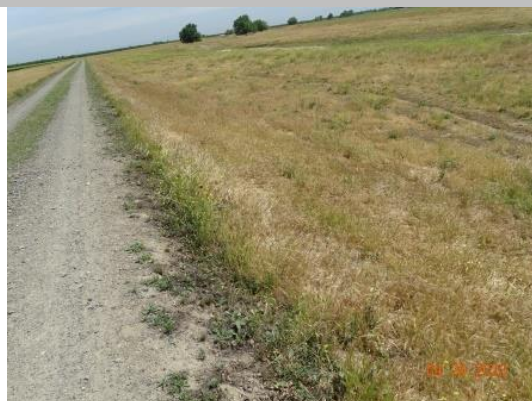
Photo 1 of 1 : SP_2020_NA0010_131_13_20200508_00020.jpg

LM Start	0.31	Rating **	M	Issue No.	13
LM End	0.95	Issue Type +	Ma	Location *	WS
Category	Earthen Levee			GPS Latitude/Longitude	
				Start	End
Item	Vegetation			37.038021 °	37.045107 °
				-120.440313 °	-120.433517 °
DWR ID	DWR_NA0010_13_s_2020_13				
Comment Code					
V1 : Control annual grass and weeds on the levee slopes and easements.					
Inspector Comment

View of the waterside slope looking upstream. (Spring 2020)

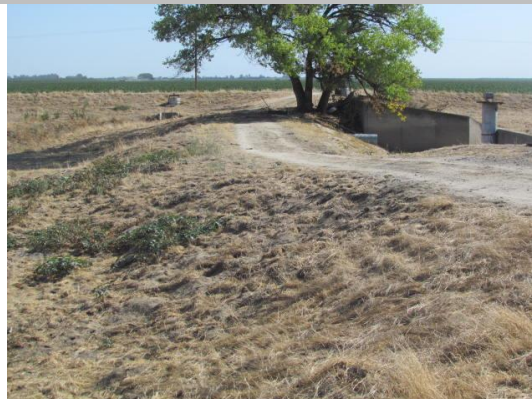
Photo 1 of 1 : SP_2020_NA0010_131_6_20200225_00006.jpg

LM Start	1.14	Rating **	U	Issue No.	6
LM End	1.14	Issue Type +	En	Location *	WS
Category	Earthen Levee			GPS Latitude/Longitude	
				Start	End
Item	Encroachments			37.045541 °	37.045541 °
				-120.430014 °	-120.430014 °
DWR ID	DWR_NA0010_13_f_2015_6				
Comment Code					
WL : Wall					
Inspector Comment					
Sand dam may have been blown out due to high flows in 2017 but has been restored. The sand dam referenced in this issue is an unauthorized construction in the channel by the landowner. It blocks the entire channel.

Looking overview of sand dam.

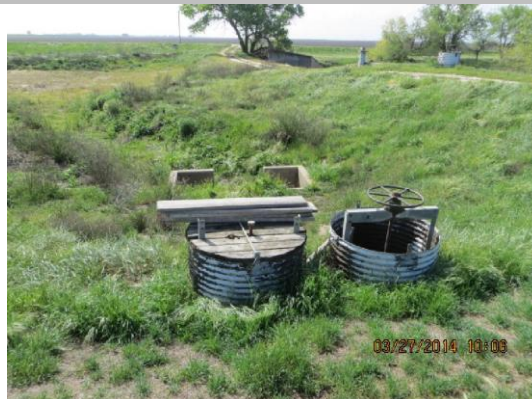
Photo 1 of 3 : UCIP_SP_2020_39877_59385.jpg

Comment Code						
Inspector Comment						
DS_ID:19727 FS_ID:39877 EP_NO: N/A Repair Type: Non-Urgent Crossing Status: Found UCIP Comments: 03/27/2014 Appears abandoned and if so should be done so properly. Pipe filled with soil on WS at outlet. Actuator missing from slide gate on WS shoulder. (DWR UCIP - W. Wylie) FIELD_STRUCT_DESC: [Rounder Irrigation Structure] 1 of 2: 36-inch corrugated metal gravity drainage pipe through the levee, 12.3 feet below the crown. Slide gate in a 48-inch corrugated metal pipe (CMP) riser on the waterside (WS) slope. 6-foot by 12-foot concrete distribution box on the landside (LS). 7-foot by 14-foot concrete outlet structure on the WS toe. [Additional Reference(s): DWR Levee Log, 2002. USACE San Joaquin O&M Manual 601.1, 1967, (HLM 1.14)]. FS Date: 3/27/2014

Slide gate in CMP riser on WS shoulder.

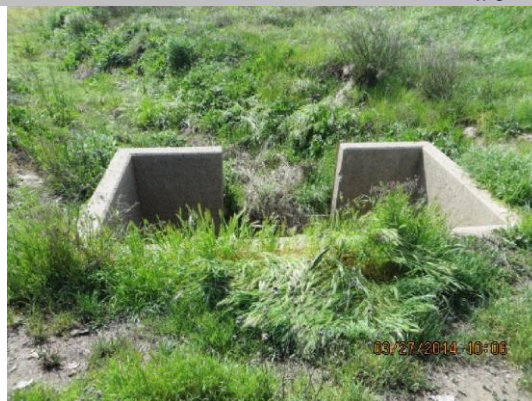
Photo 2 of 3 : UCIP_SP_2020_39877_59384.jpg

Concrete box on WS toe.

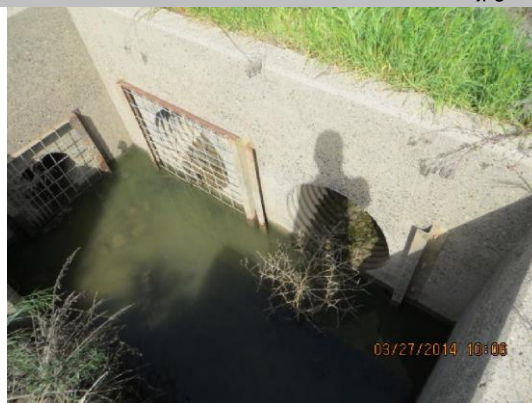
Photo 3 of 3 : UCIP_SP_2020_39877_59389.jpg

Concrete box on WS toe.

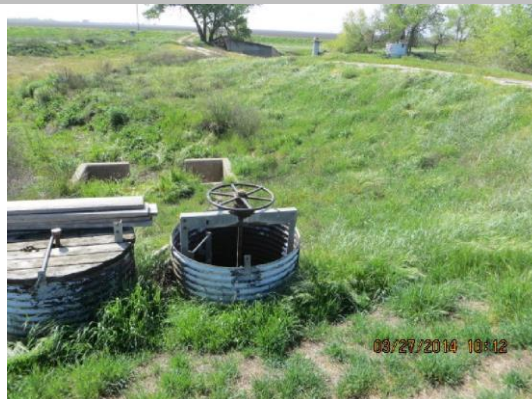
Photo 1 of 3 : UCIP_SP_2020_39524_59390.jpg

DS_ID:19908
FS_ID:39524
EP_NO: N/A
Repair Type: Non-Urgent
Crossing Status: Found
UCIP Comments: 03/27/2014 No lid on riser at WS shoulder could be safety issue. (DWR UCIP - W. Wylie)
FIELD_STRUCT_DESC: [Rounder Irrigation Structure] 2 of 2: 36-inch corrugated metal gravity drainage pipe through the levee, 12.3 feet below the crown. Slide gate in a 48-inch corrugated metal pipe (CMP) riser on the waterside (WS) slope. 6-foot by 12-foot concrete distribution box on the landside (LS). 7-foot by 14-foot concrete outlet structure on the WS toe. [Additional Reference(s): DWR Levee Log, 2002. USACE San Joaquin O&M Manual 601.1, 1967, (HLM 1.14)].
FS Date: 3/27/2014

Slide gate in CMP riser without at lid on WS shoulder.

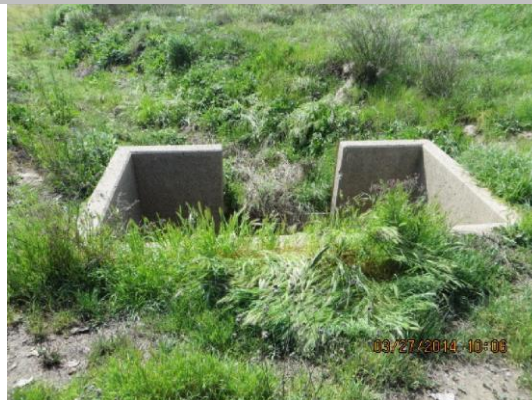
Photo 2 of 3 : UCIP_SP_2020_39524_59392.jpg

Concrete distribution box on WS toe.

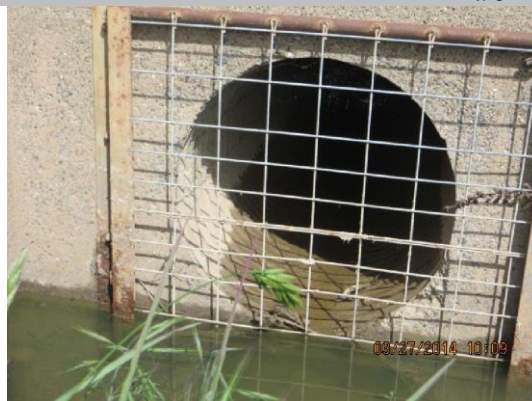
Photo 3 of 3 : UCIP_SP_2020_39524_59391.jpg

Pipe at outlet on WS toe.
